# Arborist Report

Rancho de Calistoga, HCA Management  
1450 Grant Ave, Novato, CA

Prepared by Deva Braden, CA WE-7034A  
January 25, 2015

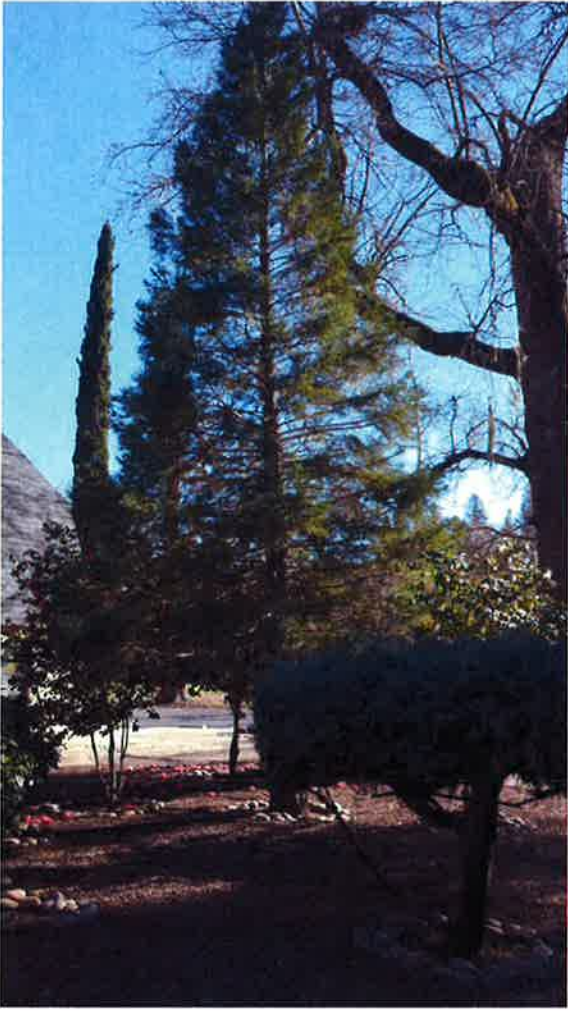
Photo1. Showing R001

**R001:** 14" DBH Sequoia; 35' tall; 15' wide canopy, good condition, falls within development footprint. **Protected** by City of Calistoga.

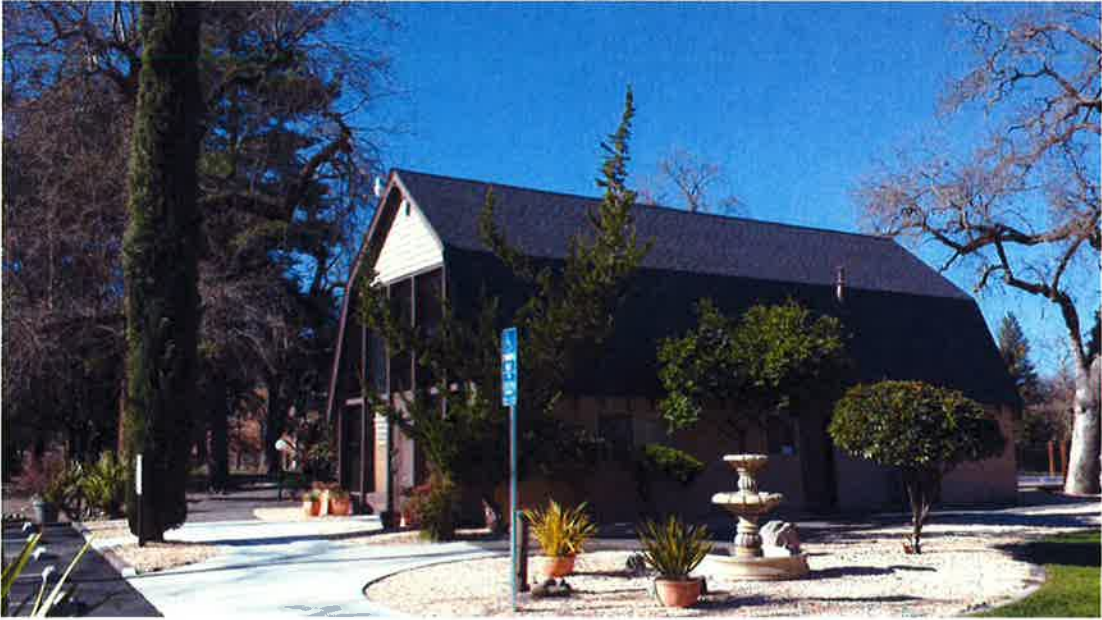
Photo2. Showing R002, R003, R004

**R002:** unknown evergreen treelike shrub, 5" DBH, 16' tall, 16' wide canopy, good condition, up against office building to be removed. Not protected by City of Calistoga.

**R003:** 7" DBH Holloway Juniper, 25' tall, 15' wide canopy. Good condition, up against office building to be removed. Not protected.

**R004:** 9" DBH Italian Cypress, 50' tall, 4' wide canopy. Good condition. Falls within development footprint. Not protected.

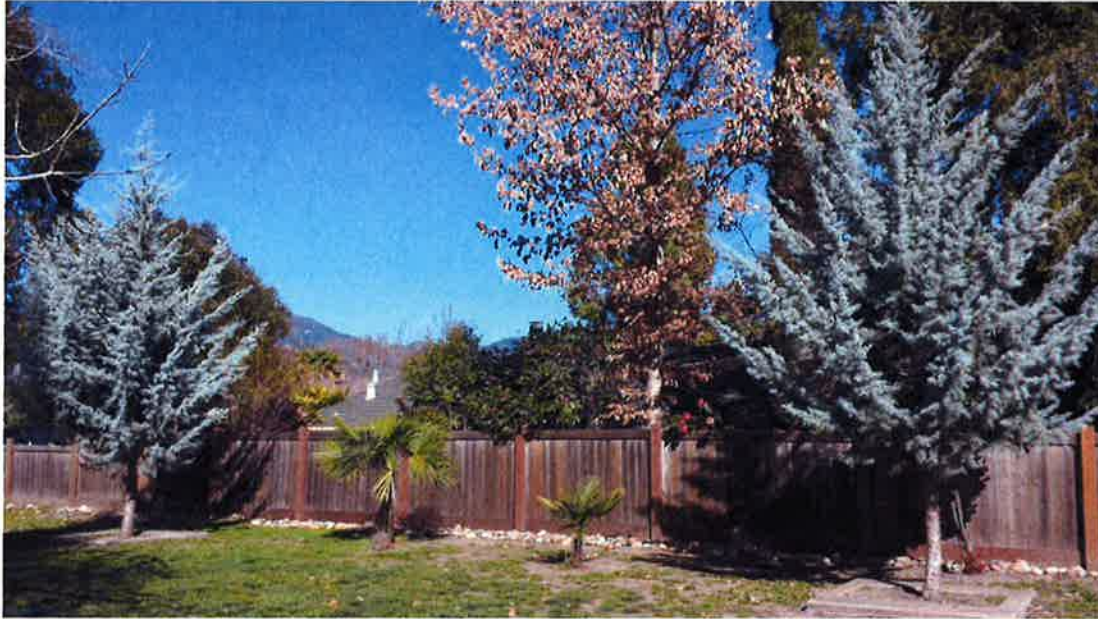
Photo3. Showing R005, R006, R007, R008.

**R005:** 5.5" DBH Juniper tree, 20' tall, 12' wide canopy. Good condition. Falls within development footprint. Not protected.

**R006:** 5" DBH (Diameter at 4.5 feet was less than 0). Palm tree, 6' tall, 6' wide canopy, good condition. Falls within development footprint. Not protected.

**R007:** 4" DBH (Diameter at 4.5 feet was less than 0) palm tree, 3.5' tall, 2' wide canopy, good condition. Falls within development footprint. Not protected.

**R008:** 4.5" DBH Juniper tree, 20' tall, 10' wide canopy, good condition. Falls within development footprint. Not protected.

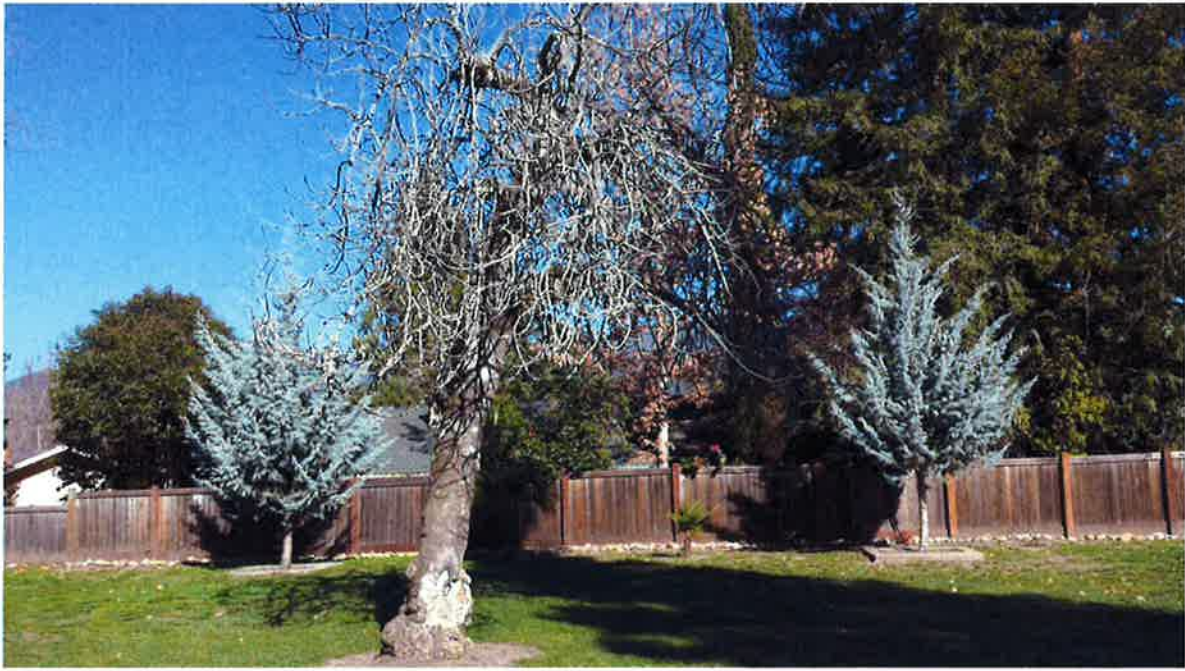
Photo4. Showing R009.

**R009:** 16" DBH Fig tree, 25' tall, 18' wide canopy, poor condition, large basal cavity. Falls within development footprint. **Protected** by City of Calistoga.

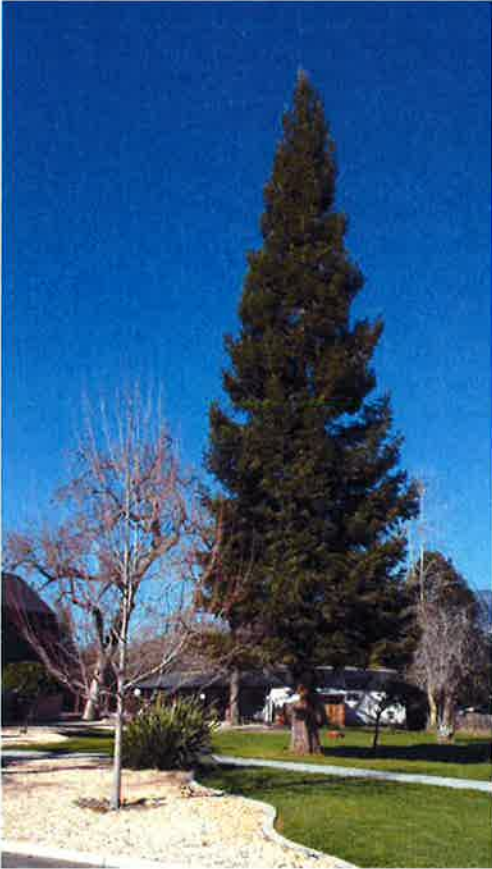
Photo5. Showing R010 and R011.

**R010:** 28" DBH Coast Live Redwood, 65' tall, 24' wide canopy, good condition. Falls within development footprint. **Protected** by City of Calistoga.

**R011:** 4" DBH Liquidambar tree, 20' tall, 15' wide canopy, good condition. Falls within development footprint. Not protected.
