MACNAIR
&
ASSOCIATES
CONSULTING ARBORISTS AND HORTICULTURISTS

AT&T Project at Calistoga Fairgrounds Tree Evaluation and Construction Impact Assessment Report

October 29, 2013

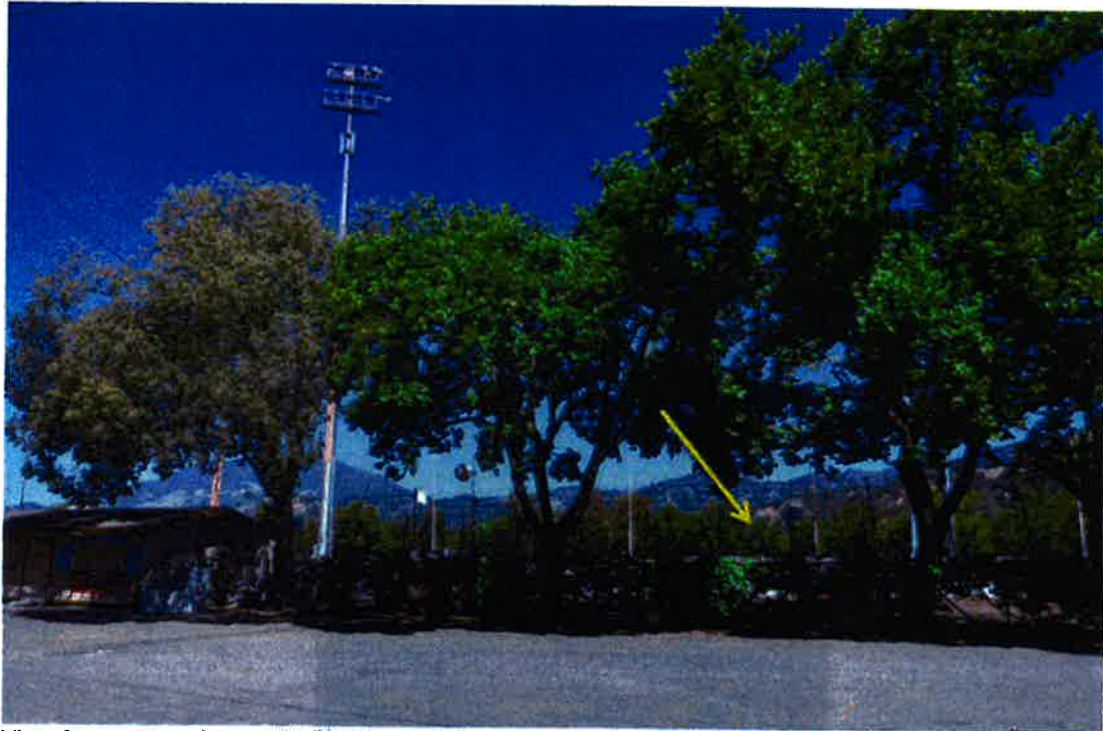
View from south of trees #1-#3. Arrow indicates proposed location of AT&T equipment shelter between trees #2 and #3.

Because the equipment building and generator slab are located within five to seven feet of trees #2 and #3, a pier and grade beam type foundation is recommended. This type of foundation will avoid significant root impact by bridging over the root zones of these two trees. Generally root protection

An alternative recommendation is to relocate the equipment shelter to an open area near the access road gate. This area previously had a large water tank, which is shown on the plans, but has been removed since the site survey work in July. If practical, this alternative location would reduce potential impacts to trees #2 and #3.

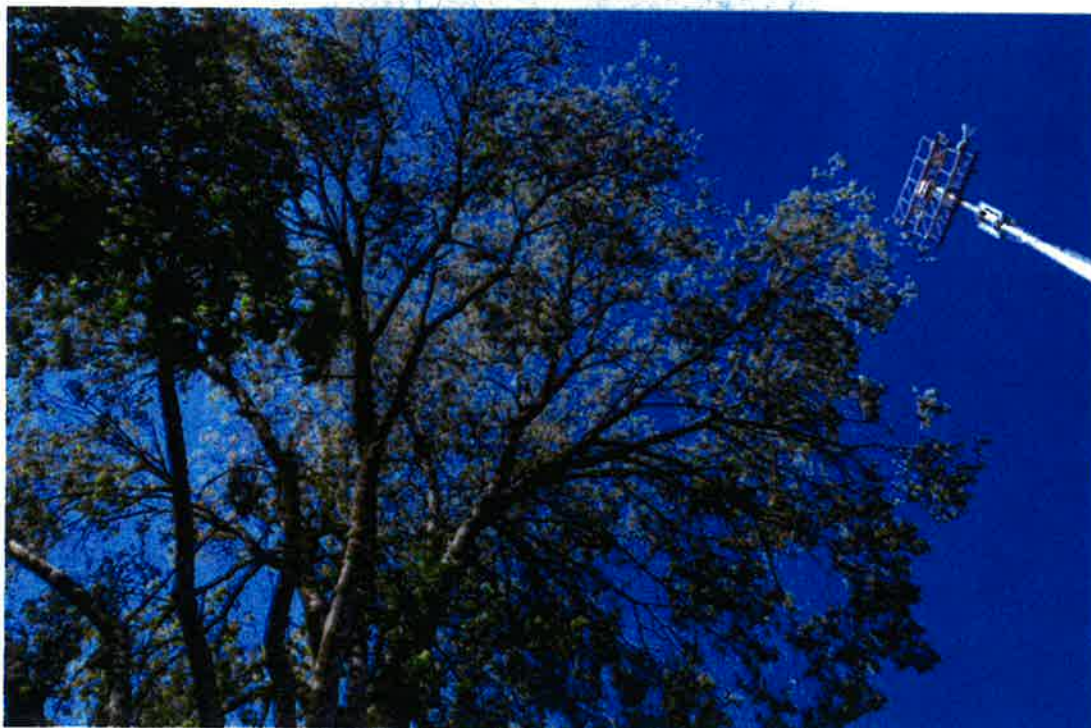
Upper crown of tree #1 with low foliage density due to chronic drought stress.

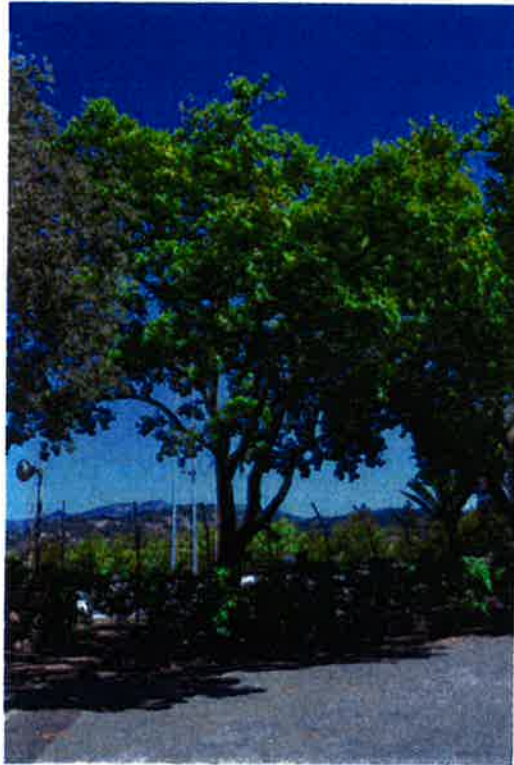
Tree #2, Chinese hackberry.

2	Chinese hackberry (<i>Celtis sinensis</i>)	24"	1	50'±	60'±	2.5	2.0	Mature tree with three closely spaced secondary trunks at 10'. Moderately asymmetrical crown form extending to south. Old, decayed trunk wound on north side. South trunk is included with an apparent fissure at union. This trunk is at risk of failure. Vigor and foliage density are variable with limited branch and twig dieback occurring. Growing in non-irrigated area.	Marginal	Located 5'-7' from equipment shelter and generator slab. Possible impact.	Yes	45'	PI
3	London plane tree (<i>Platanus acerifolia</i> "Bloodgood")	29"	1	60'±	50'-55'±	2.5	2.5	Mature tree with three secondary trunks forming at 10'-12'. Trunk unions appear sound. Probable history of old topping pruning cuts. Moderately asymmetrical crown extending south. Open limb structure. Probable lower trunk cankers (dead sapwood) on east and west sides. Growing in non-irrigated area.	Marginal to Moderate	Located 5'-7' from equipment shelter and generator slab. Possible impact.	Yes	35'	PI

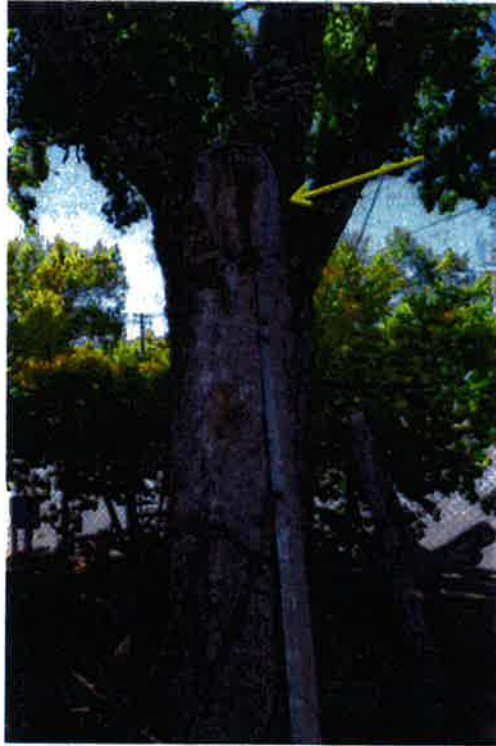
Old decayed wound on north side of tree #2

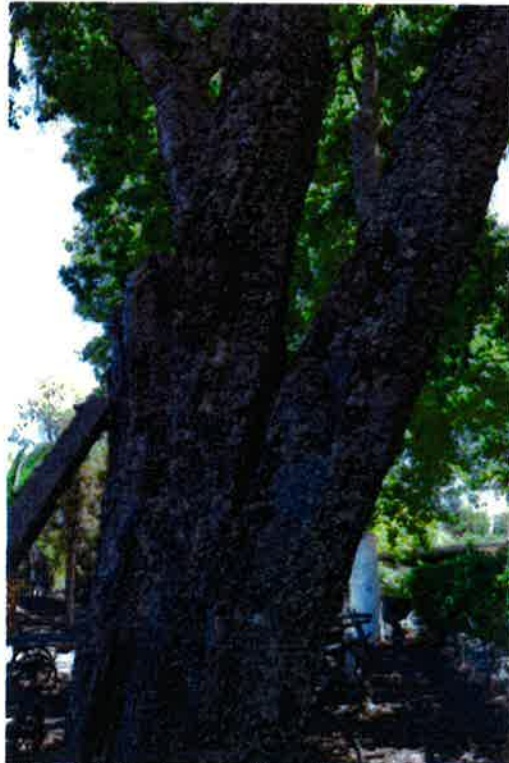
Fissure at trunk union of tree #2. Trunk is at risk of failure.

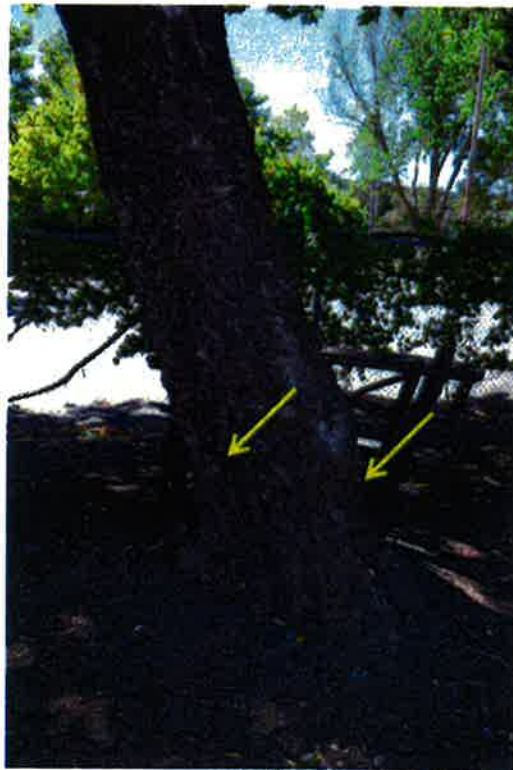
Lower trunk with probable sapwood cankers.

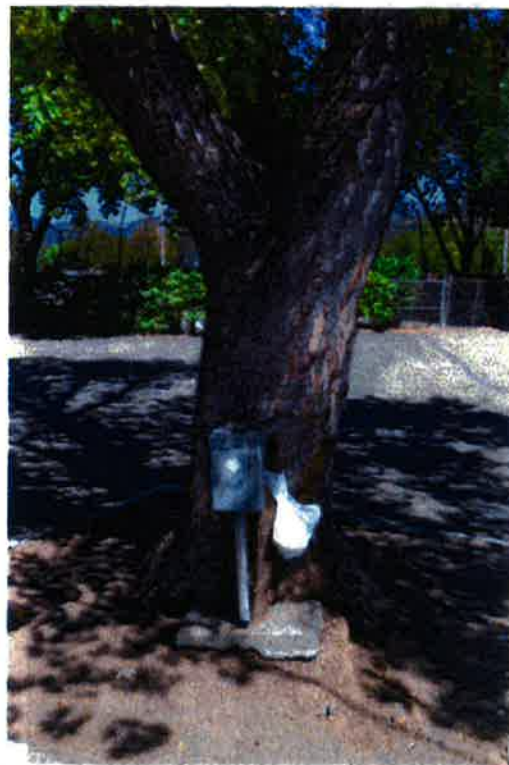
4	silver maple (<i>Acer saccharinum</i>)	33"	3 @ 6'-7'	50'±	50'±	1.5	2.0	Mature tree with three trunks forming at 6'-7'. Symmetrical crown form. Growing in small planter surrounded by asphalt pavement. Electrical utility at base of tree. Significant root damage and decay evident. Vigor and foliage density are low with significant limb dieback occurring.	Poor	Located 10'-12' from underground fiber optics route. Possible impact.	Yes	35'	PI

Lower trunk, tree #4, silver maple with electrical box.

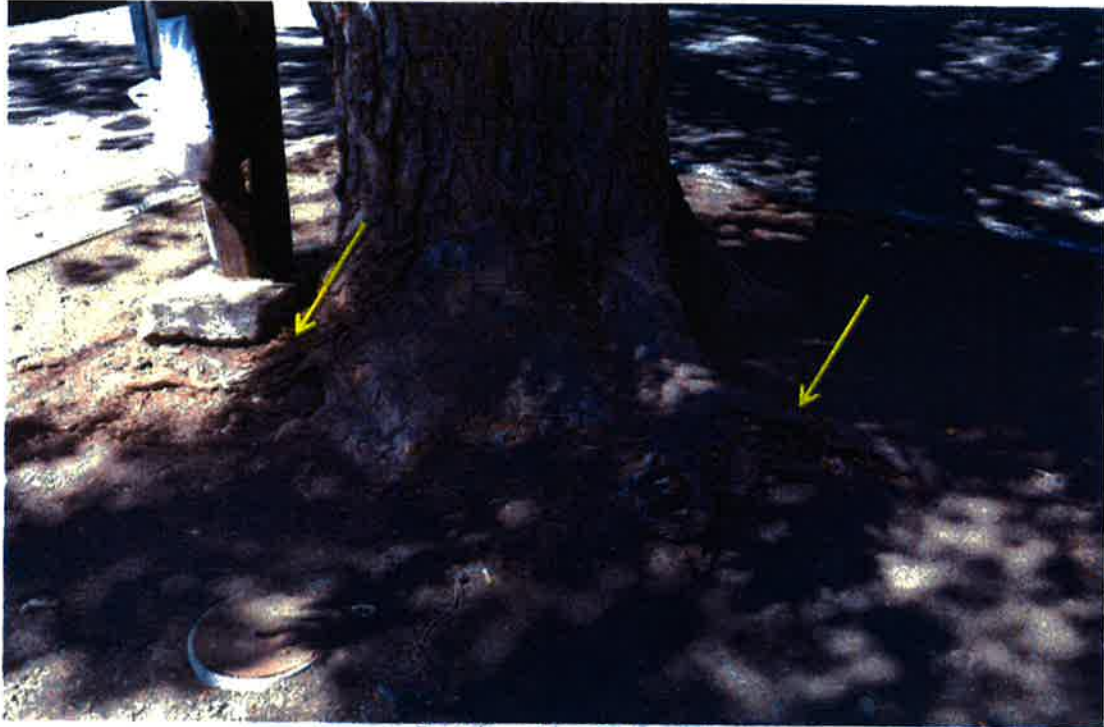
Tree #4 and decayed roots.

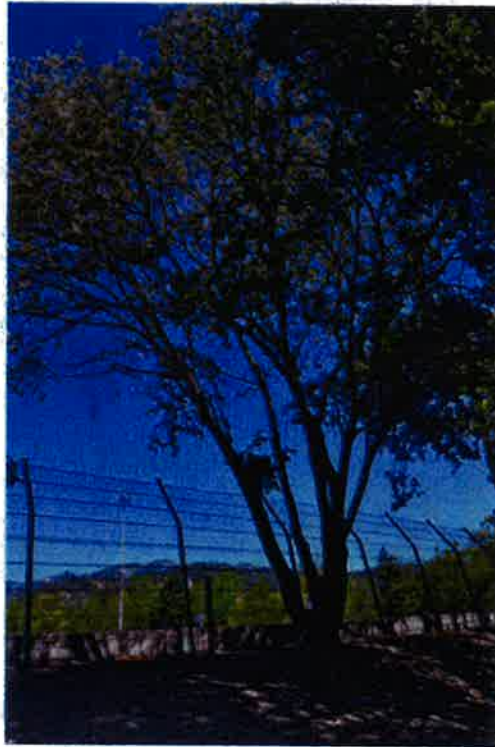
Tree #5, European hackberry, on slope above access road.

Tree #	Species	Trunk Diameter (inches) @ 4.5'	# of Trunks	Crown Height	Crown Diameter (average)	Health Rating	Structural Rating	Comments/Observations	Suitability for Preservation (Based on Condition)	Construction Impact	Protected Tree Status	Root Protection Zone (Radius in Feet)	Impact Code
5	European hackberry	12", 12", 14"	3	45'±	45'-50'±	2.5	3.0	Multiple trunk tree with generally upright and symmetrical crown form. Limited decay observed at older pruning wounds. No significant structural defects observed. Vigor and foliage density are moderately low due to lack of irrigation. Growing on slope below racetrack wall.	Moderate	Located away from current project area. Located 40' from suggested alternative shelter location. No impact expected.	Yes	75'	NI

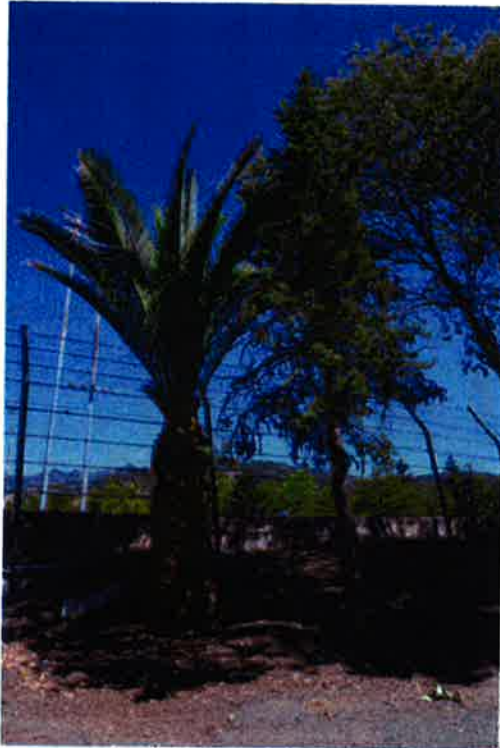
Canary Island palm and Colorado blue spruce above access road. No impact expected.

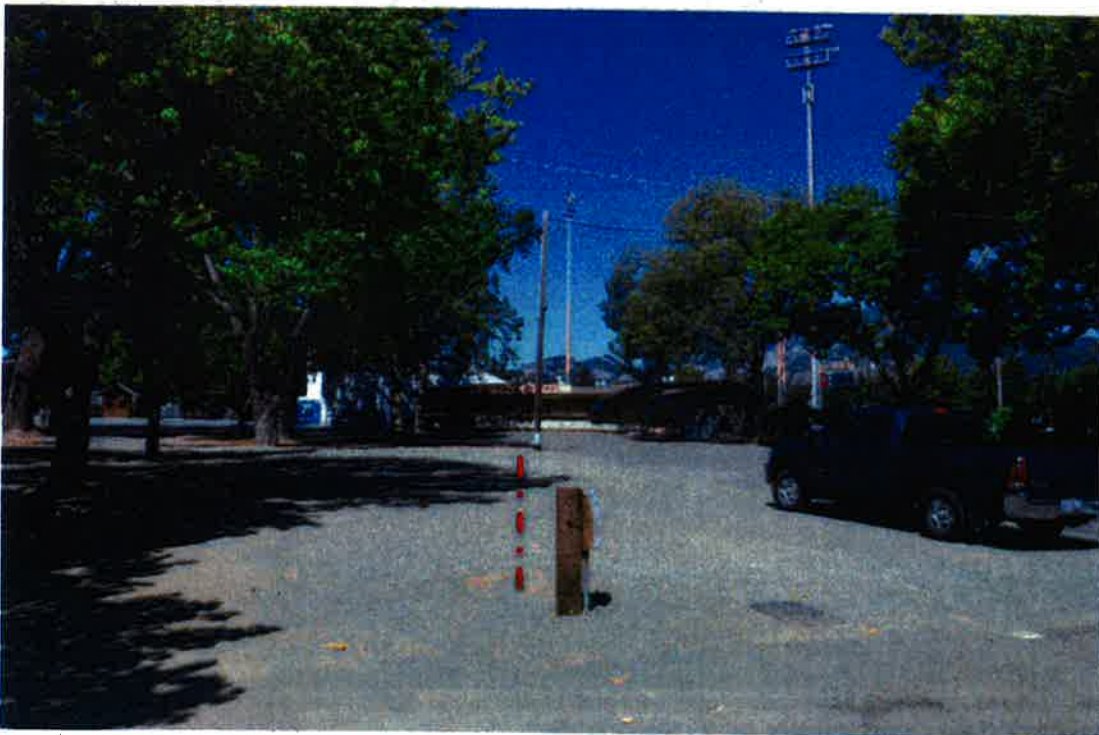
Post is AT&T fiber point of connection. Underground utility run is to pole in background and then to equipment shelter to trees on right.

The preferred method for installation of the underground utilities is directional boring. As long as the boring depth is at least four feet deep there should be no significant impact to tree root systems and no adverse effects. If an open trench is required, then the root protection requirements described in the tree protection procedures will apply.

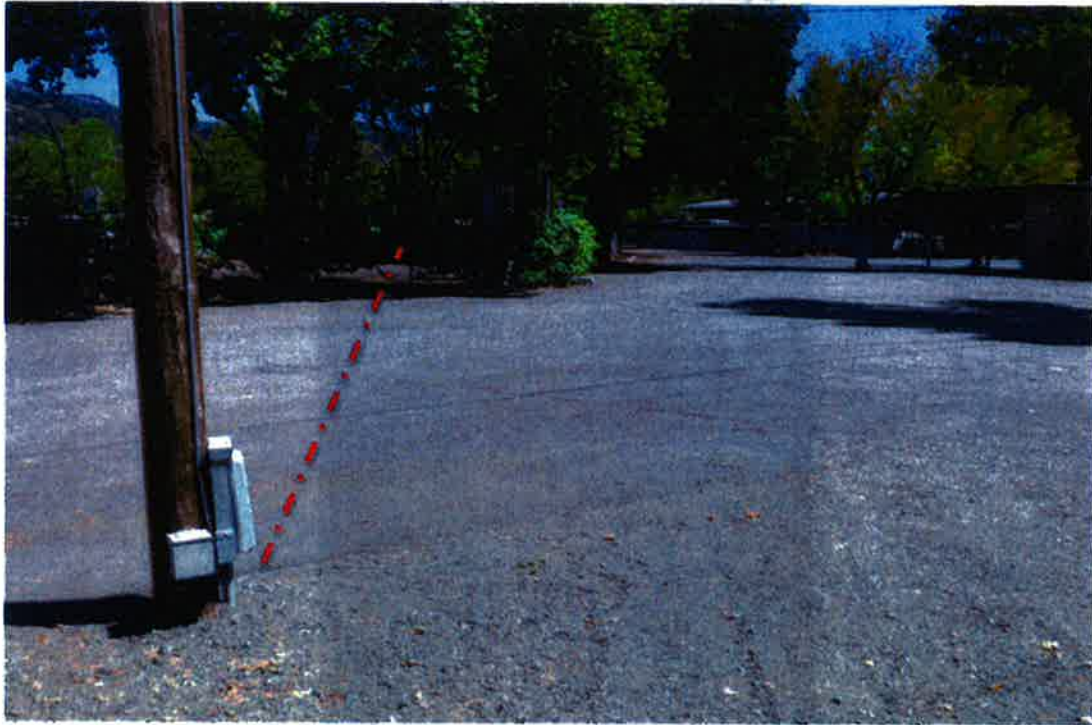
Underground utility runs from this pole to equipment shelter between trees #2 and #3.

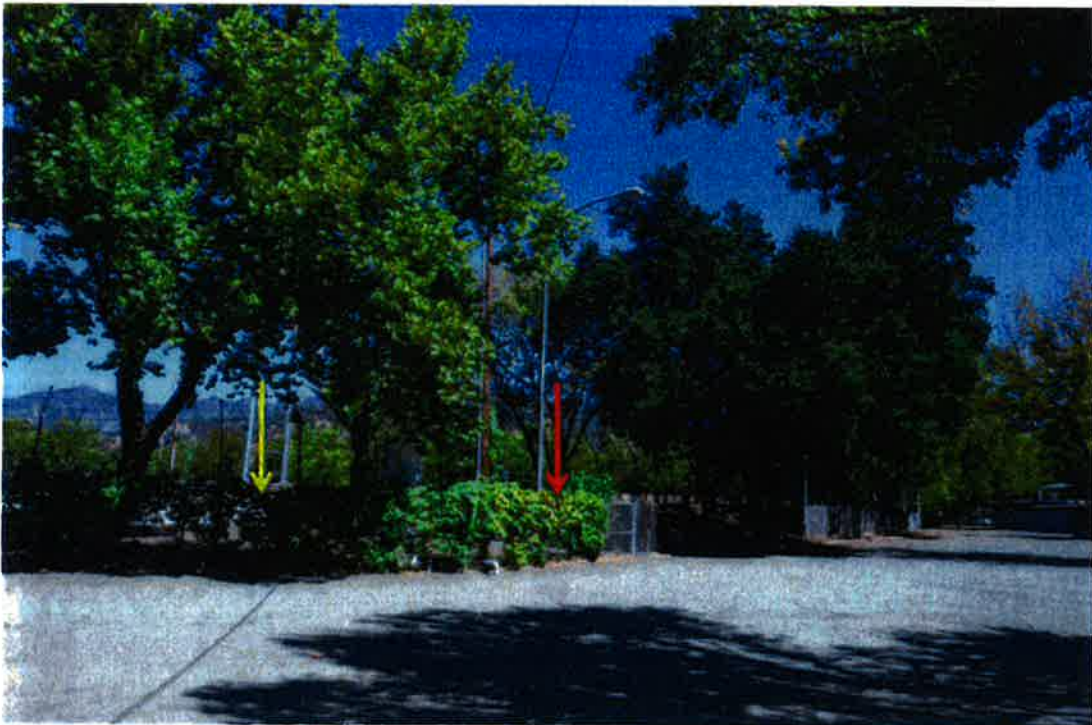
Arrow indicates suggested alternative equipment shelter location to right of tree #3 near access road gate (red arrow). Yellow arrow indicates current shelter location.
