November 1, 2022

RE: Kortum Canyon Arborist Report

According to your request, I have evaluated trees impacted by the proposed road improvements on the Kortum Canyon project site in Calistoga, CA. This evaluation identifies the trees within the roadway grading limits and assesses their health and structural condition. Also provided is an overview of general tree health on the project site.

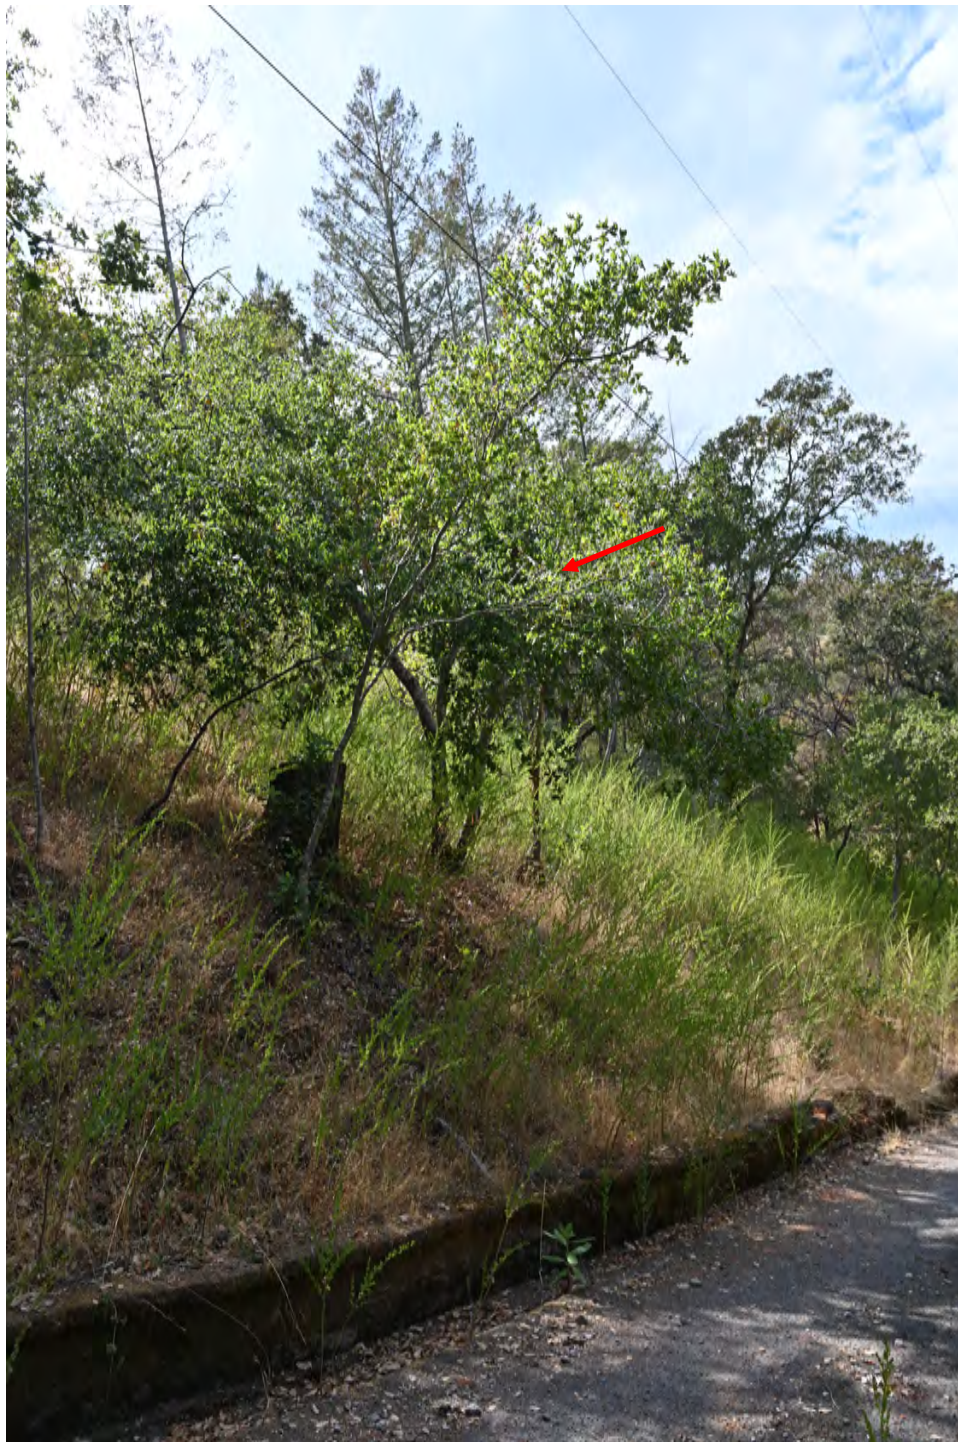
Tree #1, a coast live oak located in future road turnout. Located below electrical distribution lines and subject to clearance pruning.

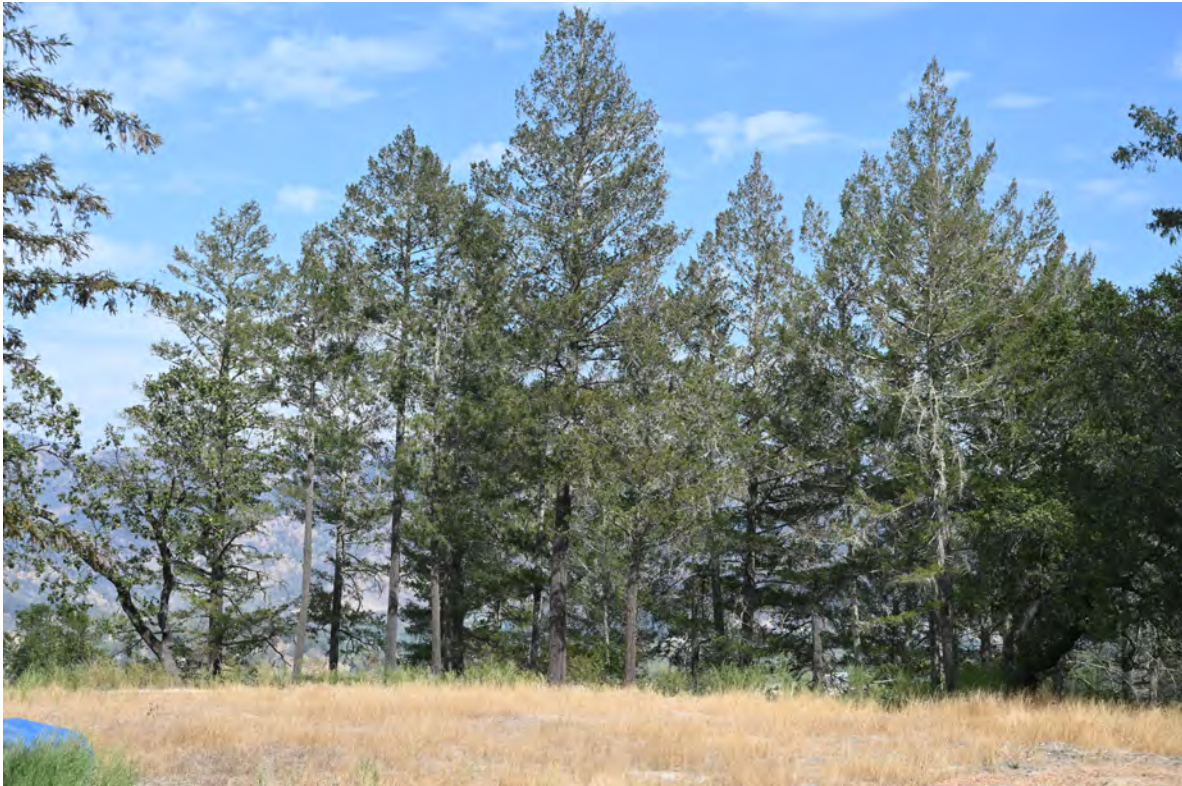
View of trees located in roadway realignment grading limits. Sixteen trees will require removal. The Douglas firs are in marginal health due to drought and boring insect attacks (flatheaded fir borer).

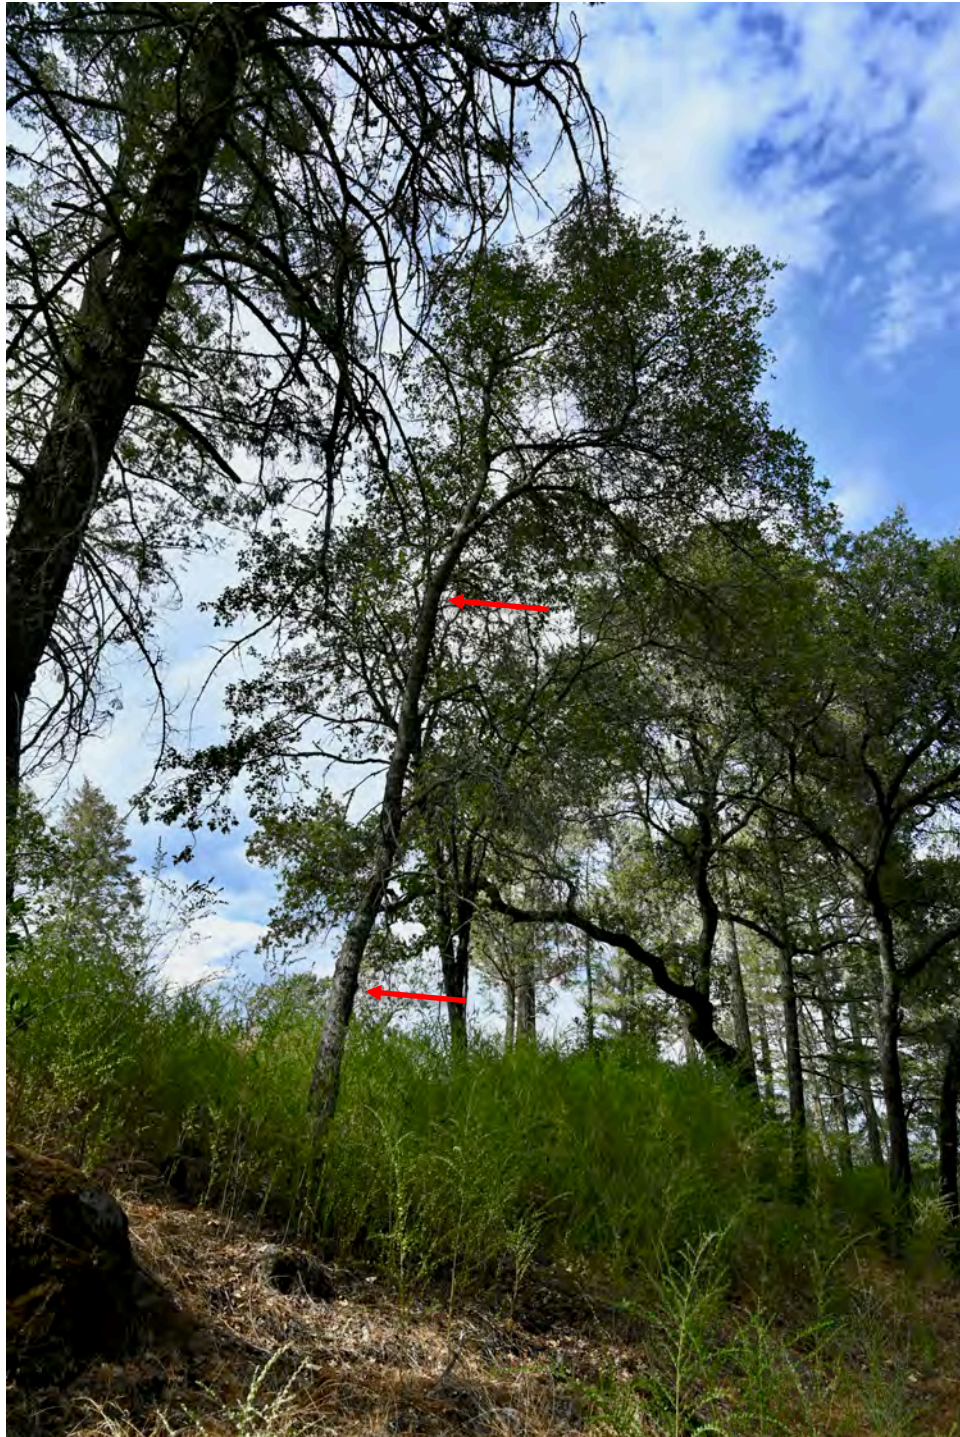
Tree #13, a coast live oak likely located in the road grading limits.

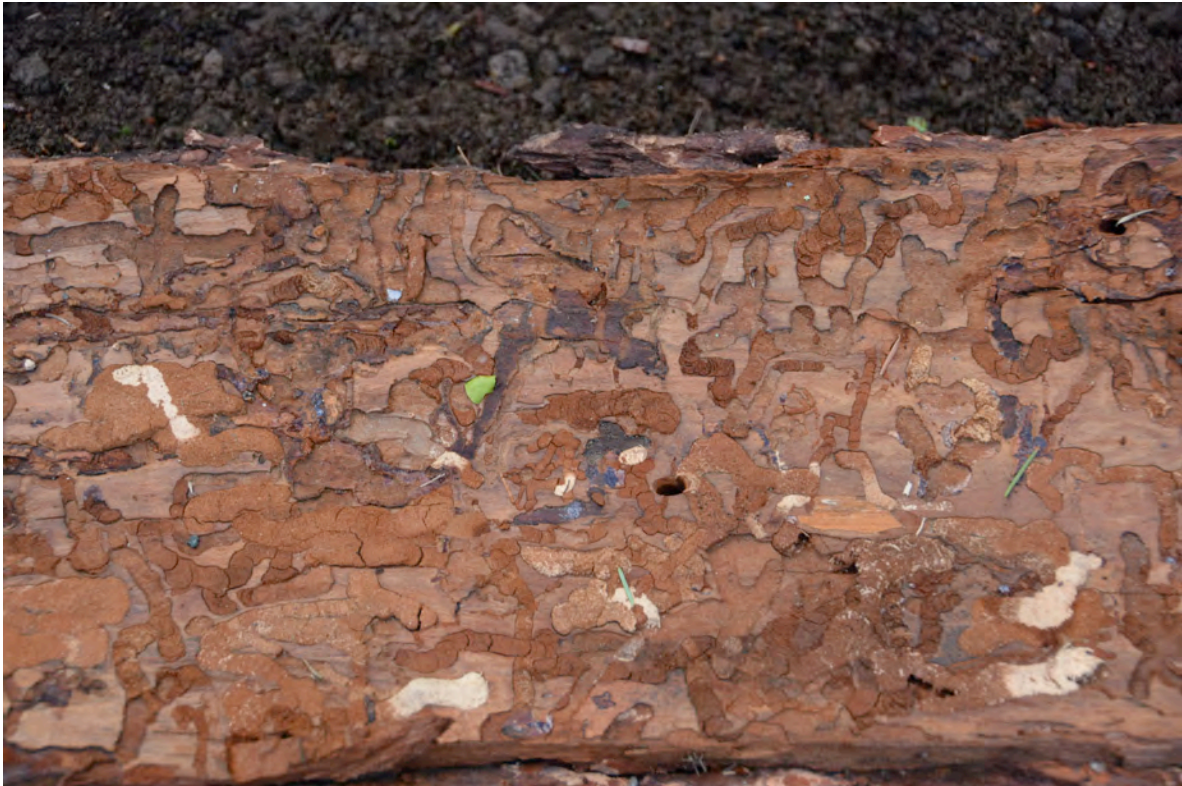
Larval galleries of the flatheaded fir borer (Kenwood, CA)

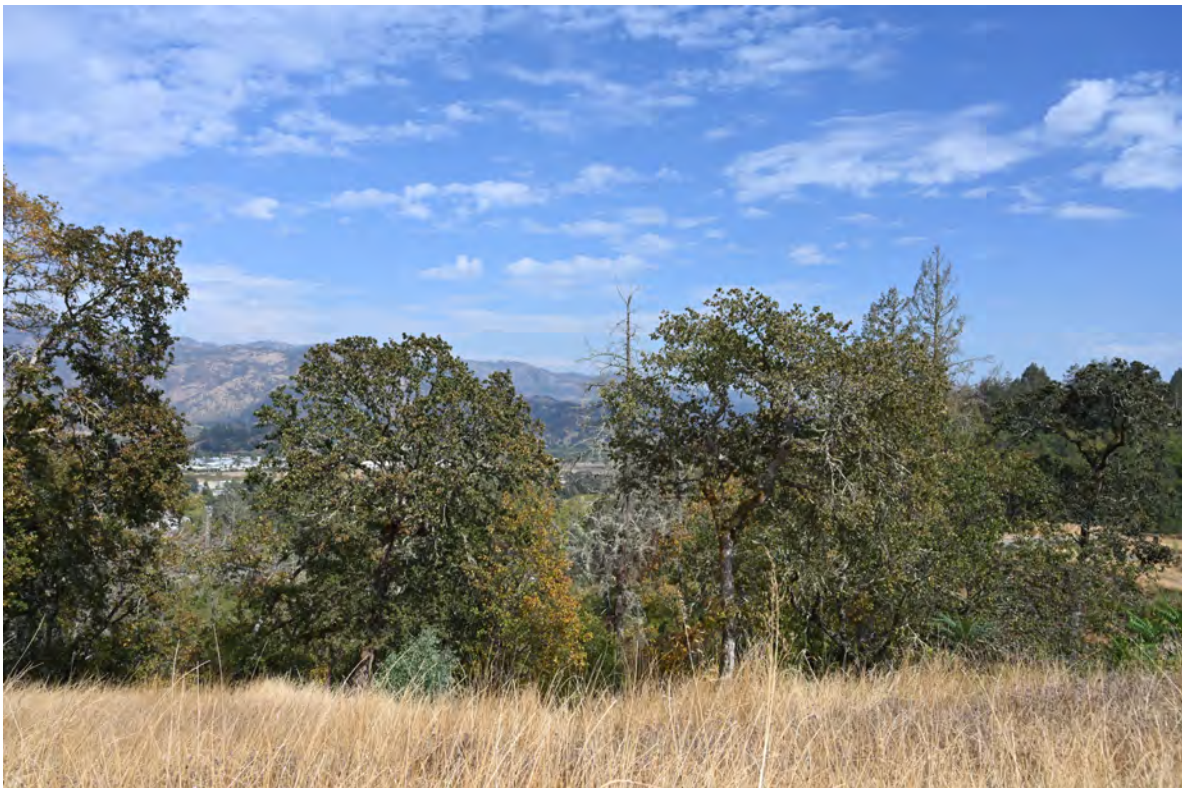
The various native oak species are generally in moderate condition despite the drought conditions.
