203 Wapoo Avenue Plan

Sam Brannan General Store-State Landmark No. 684

Curtis & Nicole Winslow and WTS+S, LLC 1001 Myrtle Street, Calistoga, CA 94515 (707) 341-3039, wtsasllc@gmail.com June 29th, 2010

PROJECT DESCRIPTION

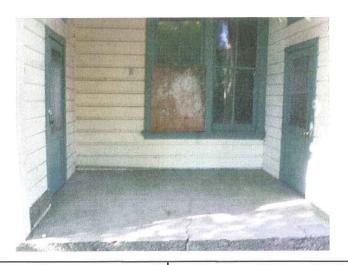
EXT-SW Porch

Historical Restoration of window exteriors

Condition will be able to assess true condition after D&D

Finishing new coat of paint on wall

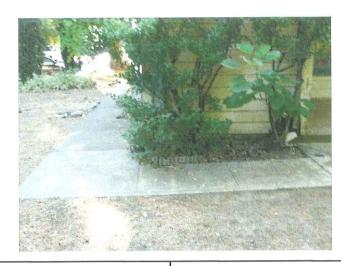
EX-08 EXT-SE Walkway

Condition will be able to assess true condition after D&D

Groundswork repair of sidewalk, see ex-04

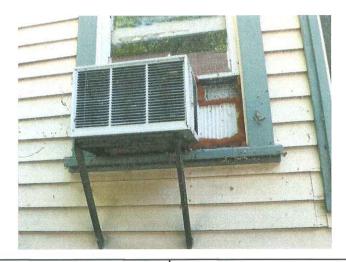
EX-15 EXT-PO-09 Wall

Condition will be able to assess true condition after D&D

Finishing new coat of paint on wall

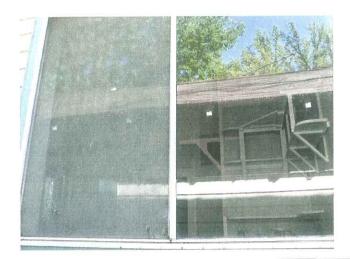
EXT-GS-04 Wall

Condition will be able to assess true condition after D&D

Finishing new coat of paint on wall

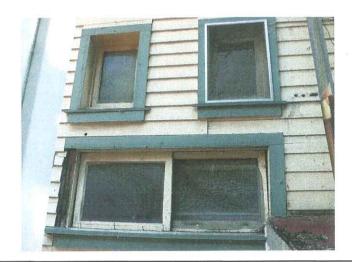
EXT-GS-01 Wall

Condition will be able to assess true condition after D&D

Finishing new coat of paint on wall
