City of Calistoga
Building Standards Advisory and Appeals Board
Agenda Item Summary

DATE	April 11, 2018
ITEM	Seismic Retrofit at 1343-1347 Lincoln Avenue: Proposed exterior retrofit for two building facades of a historically-significant building
RECOMMENDATION	Provide input as to whether proposed exterior retrofit of two facades is justified

90% FOUNDATION PLAN
 SEIBERLICH SEISMIC RETROFIT
 BUILDING PERMIT DRAWINGS
 1345 LINCOLN AVE.
 CALISTOGA, CA 94515

**HISTORIC RESOURCE EVALUATION OF
THE PROPERTIES LOCATED AT 1339
AND 1343 LINCOLN AVENUE,
CALISTOGA, NAPA COUNTY**

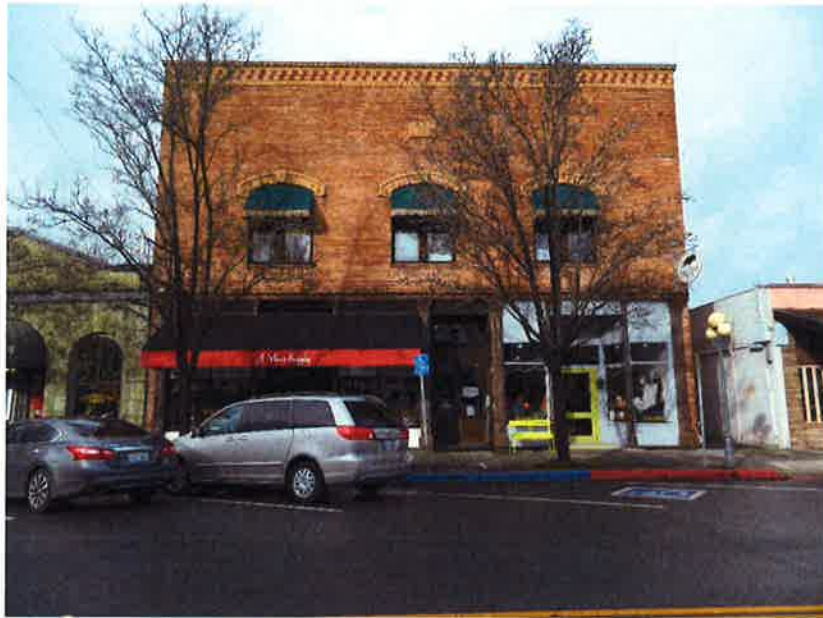
Figure 25. East elevation, facing west.

The east elevation consists of an asymmetrical designed first story and a symmetrical designed second story (Figure 25). The first story consists of a two storefronts separated by four chamfered cast-iron pilasters that have an imprint at the base reading "MC.CORMICK,BROS. S F CAL". There are four cast-iron engaged columns and four cast-iron pilasters that are significant character-defining features of the building (Figure 26). The storefronts are each designed with rounded cast-iron engaged columns that are separated by large display windows. The square-shaped cast-iron pilasters separate the storefronts and the center entryway. All of the columns and pilasters are topped by Corinthian capitals and are in good condition. The storefront, where the men's clothing store is currently located, retains its original design and features that include wood-framed display windows, bulkhead, recessed double-entry with wood paneled and glass doors, and wide, rectangular transom windows (Figure 27). The storefront, where the retail boutique is currently located, consists of the original recessed front entry, bulkhead, and large display windows; however, some of the transom windows have been partially filled with bead board, which appears to be reversible (Figure 28). The east elevation also consists of a centered, recessed front entry that is flanked by two cast-iron pilasters. The entry has the original wood and glass double door

entry and divided light transom (Figure 29). There is decorative molding that separates the first story from the second story. The molding appears to be plaster-cast and with a leaf design element that runs the length of the primary facade. The building also consists of a decorative plaster-cast cornice with Romanesque design details and a patterned band of pressed-brick elements (Figure 30). There are three segmental, paired arch windows that are topped with plaster-cast segmental arch hooded crowns. The windows are currently covered with decorative awnings that are not original to the building. Along the center of the building between the second story center window and the cornice there is a plaster-cast nameplate that reads "I.O.O.F A.D. 1887". There are also reinforced tie-rods and plates along this elevation that were added after the 1906 San Francisco earthquake.⁸

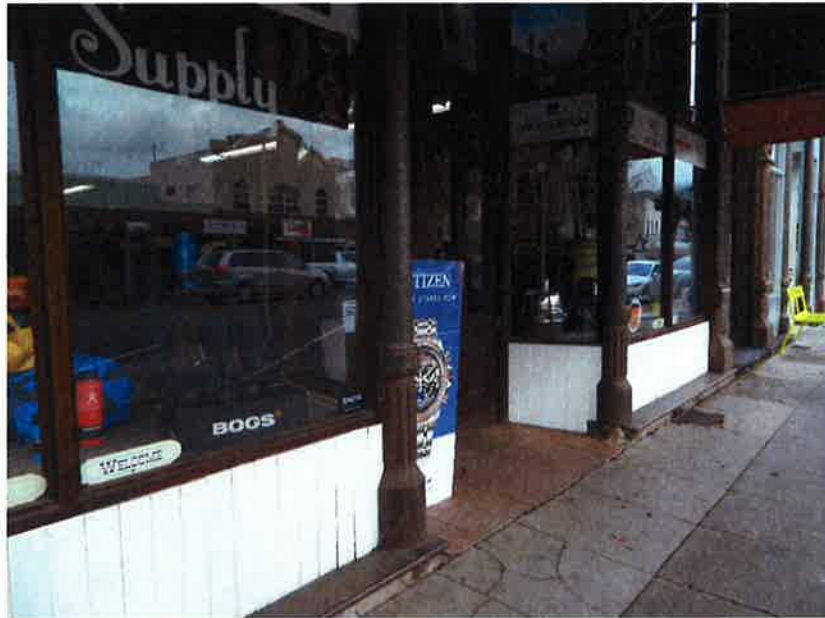
Figure 26. First Story, storefront with cast-iron columns.

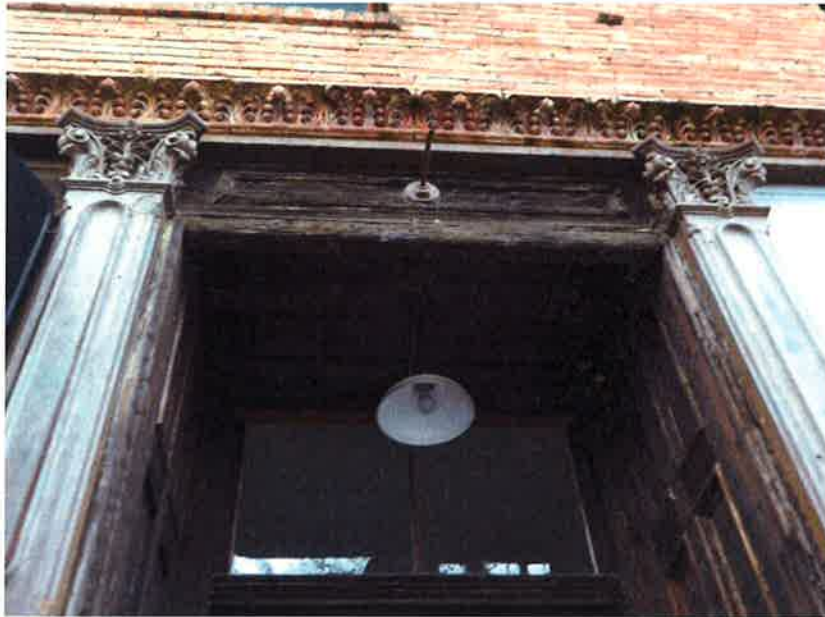
Figure 29. Corinthian pilasters at the centered second floor entry.

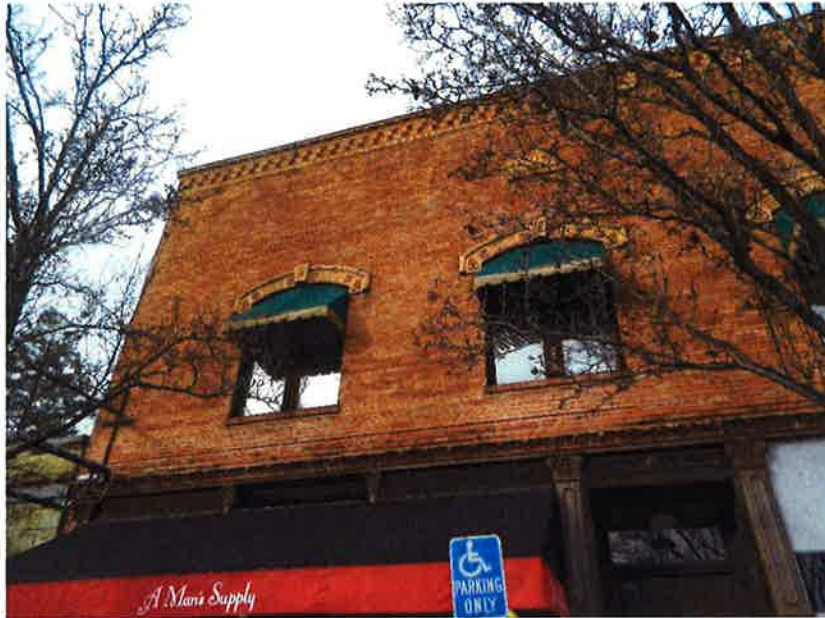
Figure 30. Second Story showing the cornice and widow crown details.

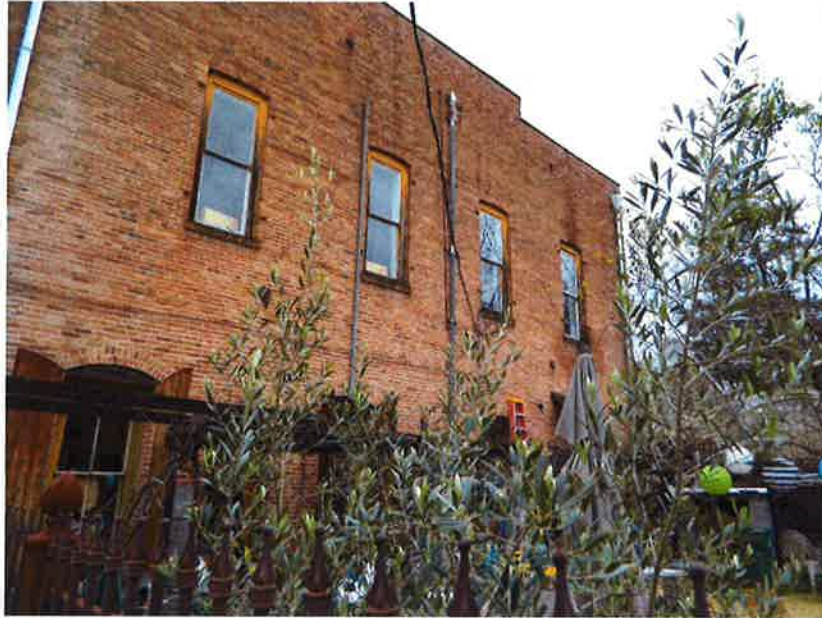
Figure 32. West elevation, facing south.

The west elevation consists of brick laid out in a common plan, four second story double-hung wood windows, and four, segmental arched double-hung, divided light windows with iron shutters.

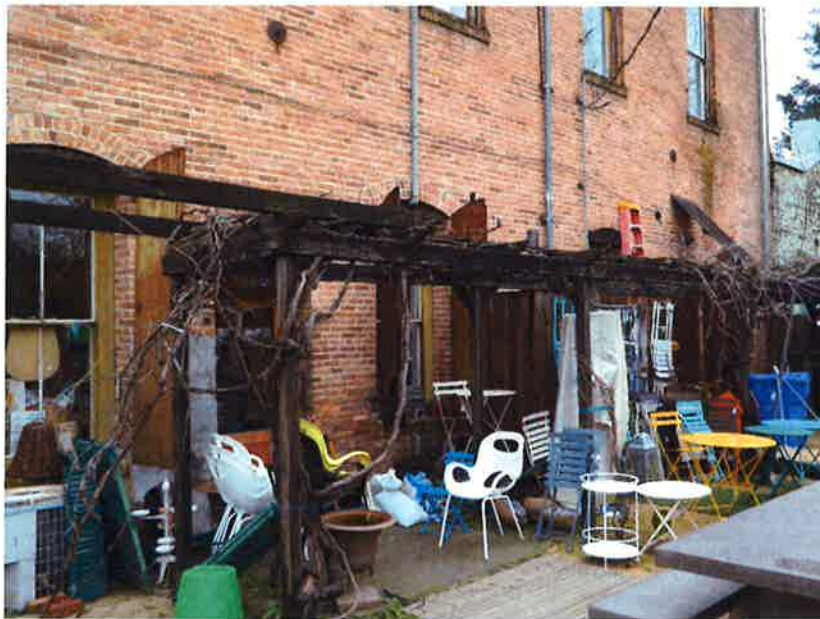
Figure 33. West Elevation, showing the iron shutters.

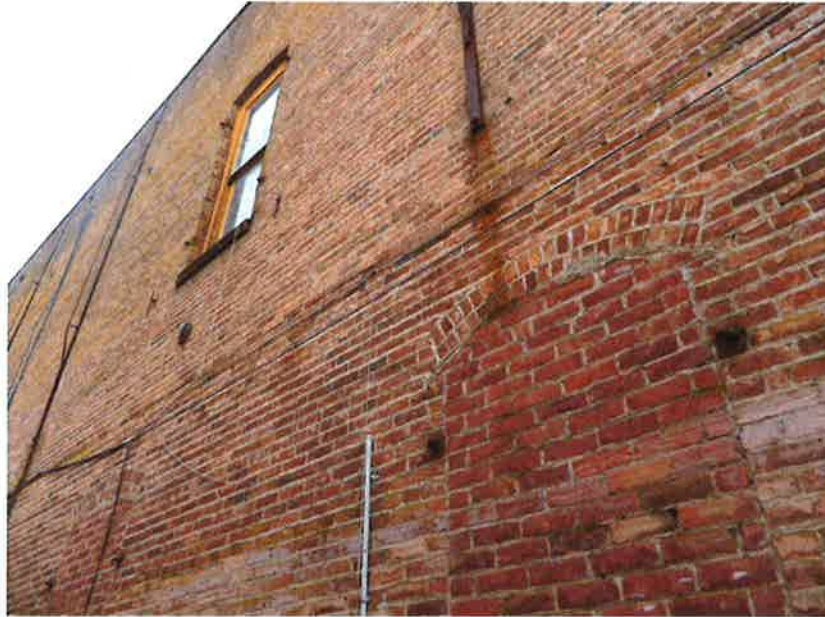
Figure 34. North Elevation, showing the filled-in window.

The north elevation consists of brick laid out in a common pattern. The windows along the first story were removed and the openings were filled-in at some point. The brick used to cover the window openings is a different color than the original brick; however, the original arched window headers are still present. The windows were likely altered during the time when the first floor was occupied by Whitney's Hardware Supply. There are two, double-hung, wood windows along the second story that are original to this elevation. There are steel plates visible along this elevation that were likely added after the 1906 San Francisco earthquake.
