Re: Secretary of Interior Standards Compliance Letter – James H. Francis House Rehabilitation Project

**SECRETARY OF INTERIOR
COMPLIANCE REVIEW
FOR THE JAMES H. FRANCIS HOUSE
LOCATED AT 1403 MYRTLE STREET,
CALISTOGA, NAPA COUNTY**

Detailed Condition Assessment

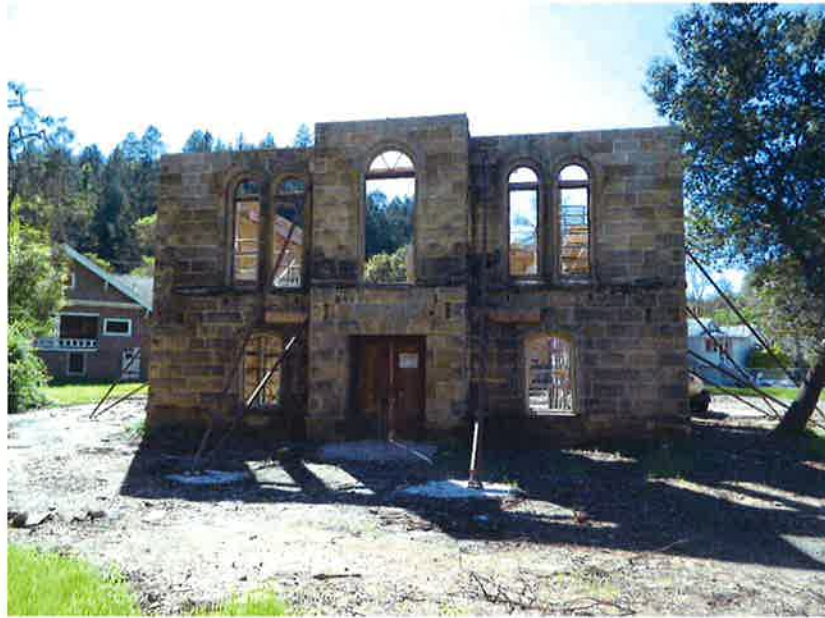
On *March 17, 2016*, Stacey De Shazo, M.A. in Historic Preservation, conducted a condition assessment of the Francis House. The current condition of the Francis House includes the original ca. 1886 square plan design with a two-story projecting pavilion that was constructed of native stone. There is coursed and roughly tooled ashlar along the east and south elevations and smoothed ashlar along the north and west elevations (Figure 1). There are decorative quoins around each corner of the building, as well as stone

moldings with articulated keystones and imposts that surround the vertical, semi-circular double-hung windows and segmented arched double-hung windows. All of these elements are considered character-defining features that are original to the ca. 1886 Francis House, and they are in good condition.

Figure 1: Francis House, facing west.

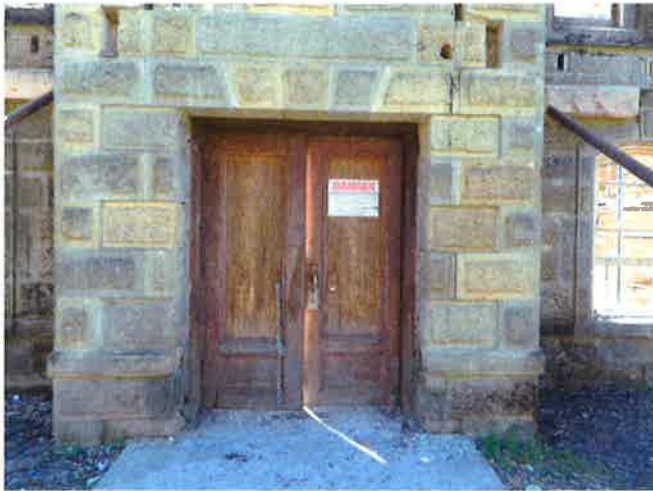
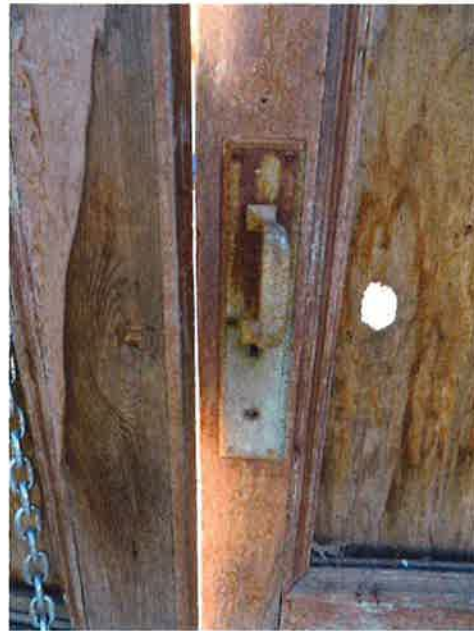
The east elevation is symmetrical and consists of three bays with a prominent centered, projecting bay. The original second floor main entrance is still present and consists of a single-door opening that is topped by a divided-fanlight transom. There is no glass within the transom; however, the redwood casing, frame, and muntins of the window are still present and appear to be in fair condition. There is no front porch or stairway to access the original second story main entry, as it was likely removed during the construction of the Calistoga Hospital portico in ca. 1918. There is little evidence of the portico that was documented in the 1978 National Register Nomination.⁷ It likely fell down or was torn down, but was not part of the 2016 safety and stabilization project. Evidence left of the portico includes small cut-out sections between the first and second story (Figure2). There are paired, vertical, double-hung windows with semi-circular arches located along the second story on both sides of the center pavilion. Along the first floor, within the central pavilion, there is a wooden double-door entry that consists of vertical panels along the upper 3/4 of each door and smaller horizontal panels along the lower 1/4 portion. The double-doors are likely original to the ca. 1886 Francis House; however, some elements of the hardware on the doors were modified after the house was converted to a hospital. The original door

hardware consists of an egg and dart designed door plate (Figure 3). Modifications include a pull handle that was likely added for easy access while the building was a hospital. There are also four small, fixed semi-circular and segmented arched windows located along the sides of the central projecting pavilion that are character-defining elements of the Francis House (Figure 4). These small windows consist of interior wood stool and stone aprons, as well as an exterior stone sills, glass window panes, and sashes that are in good condition.

Figure 2 and Figure 3: East Elevation, first floor door detail.

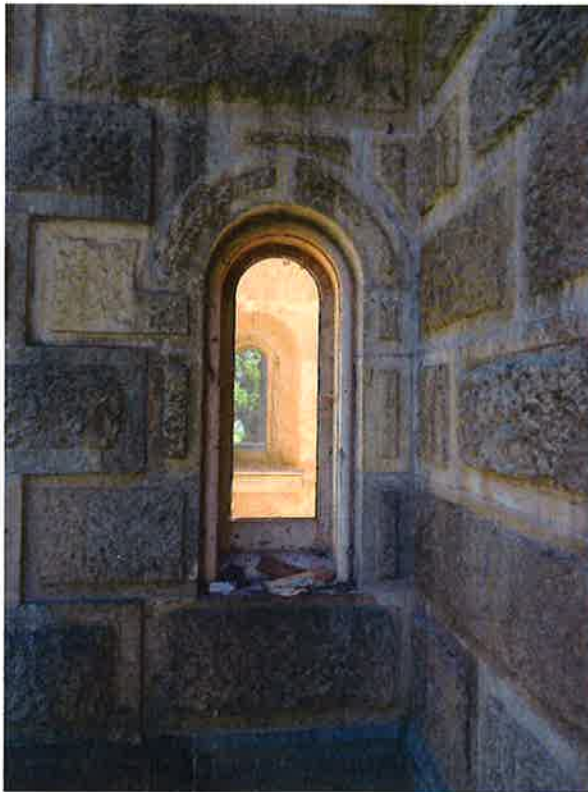
Figure 4: Central project pavilion first floor, facing south.

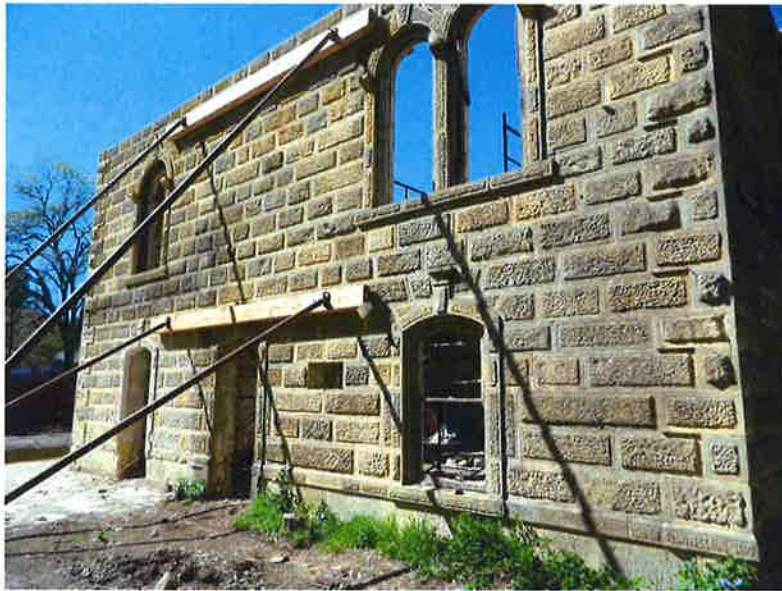
The south elevation, which is visible from the street view along Spring Street, was constructed of coursed and roughly tooled ashlar. There is one rectangular rough tooled stone along the first-story that is missing and appears to have fallen out on the ground below as well as several stones that have been removed along the lower portion of a first floor window. However, the stone and mortar have weathered well and are in good to excellent condition. There are also a row of smooth stones situated along the lower 'foundation' portion of this elevation that are less decorative and appear to serve as a stabilizing element. There are three vertical, semi-circular arched windows with stone corbels along the second story that includes one paired window (Figure 5). Several of the window frames are still present, but are missing elements such as window sashes and glass panes. Along the first story there are two segmented arched windows and a segmented arched entry doorway that is original to the house. One of the segmented arched windows along this elevation appears to have been utilized as secondary doorway at some point as the lower stones have been removed; however, the majority of the character-defining features remain intact and are in good to excellent condition.

Figure 5: South Elevation, facing northwest.

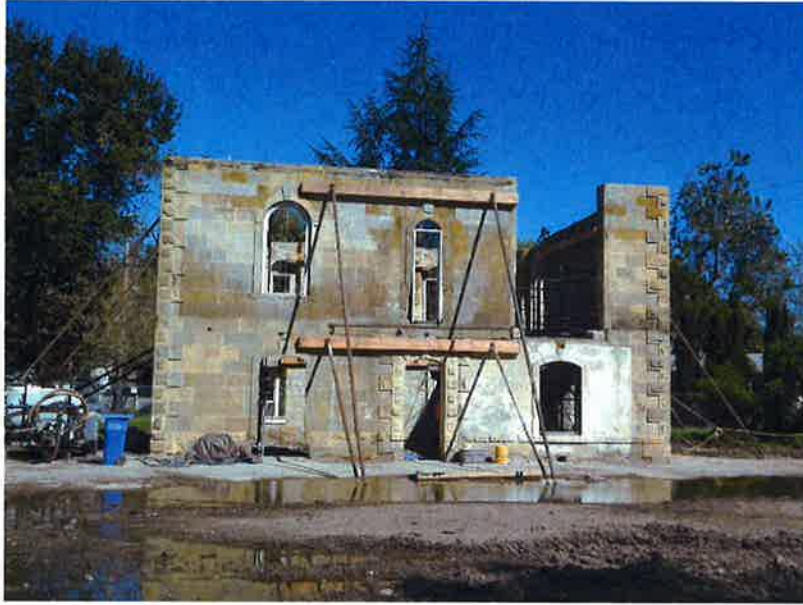
The west elevation consists of a native stone tooled as smoothed ashlar, two door openings, one semi-circular horizontal window, and two segmented arched windows (Figure 7). There is an open space along the second story near the southwest corner where a bay window appears to have been removed or modified to accommodate second floor exterior access during the time the building was utilized as a hospital. There is evidence of an original bay window based on the original design of the space and materials removed during the demolition of the wing additions. This elevation also consists of a central, second floor entry that was likely a double hung window that was modified to created access to the

two-story portion of the wing addition. Along the first story there are two segmented, arched windows and a central segmented, arched doorway that is flanked by decorative quoins, which was exposed after the demolition of the wing additions.

Figure 7: West elevation, facing east.

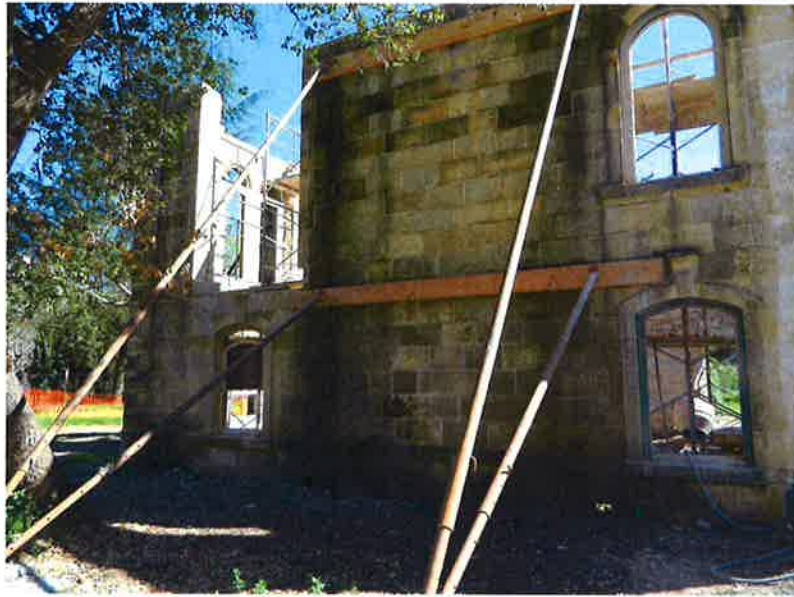
The North Elevation consists of three windows and an open section along the second story near the northeast corner where a bay window was removed and stored as part of the planned restoration work for the house (Figure 8). The three windows consist of one semi-circular window, and two segmented arched windows that were all double-hung. There is some damage to the second story window created by the wing addition, as well issues with the mansard roof due to the property being vacant for more than 50 years. However, the character-defining features such as the keystone, sill, and casing are all still present. There also appears to have been drainage issues, evidenced by staining along the stone that may have been caused by the flat roof construction of the addition that may have allowed for water to drain in areas between the original house and the addition. There is also evidence of moss growing on this elevation as it receives less sunlight exposure.

Figure 8: North elevation, facing south.

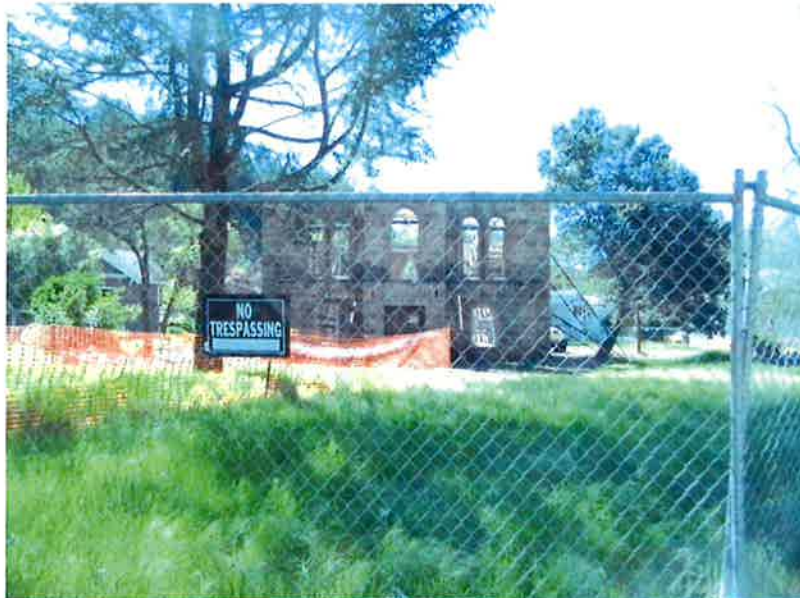
The landscape consists of fruit and nut trees, coast live oak and valley oak trees, as well as maple and black walnut trees (Figure 9). The property consists of fill, pea gravel, grasses, and a small discard pile that is a mix of soil and various other materials that was likely created during the safety and stabilization project. There are also some obsidian flakes observed on the surface within the property.

Figure 9: Corner of Myrtle and Spring Street, facing west.
